Maryland Historical Trust
Inventory of Historic Properties Form
Maryland Route 30/Manchester Bypass Project

1. Name (indicate preferred name)historic Berwager Farmand/or common Bentz Farm**2. Location**street & number 3727 Water Tank Road not for publicationcity, town Millers X vicinity congressional district 6thstate Maryland county Carroll County**3. Classification**

Survey No. CARR 1512

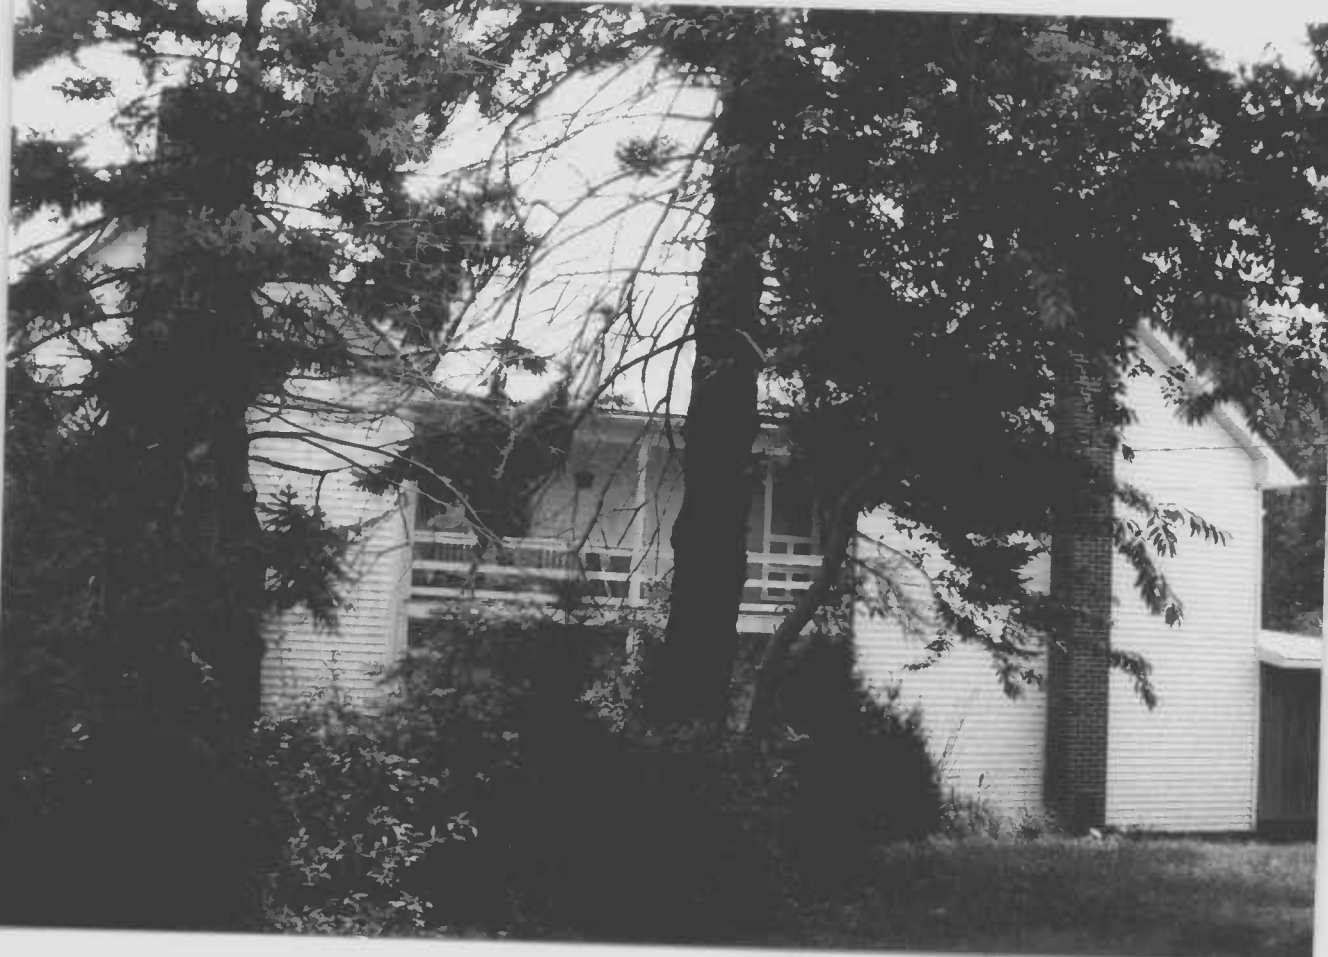
According to Mrs. Bentz, the house was built circa 1875. The 2-1/2 story, clapboard I-house is two bays by one bay with one-over-one sash and vinyl siding. The metal gable roof is parallel to the road and a concrete porch with wood posts and balustrade traverses the principal [north] elevation. Fenestration is regular with one-over-one sash.

1. CARR 1512
2. CARROLL County
3. Madeleine Scheerer
4. June, 1996
5. Maryland SHPO
6. Bentz Farm - house - north elevation
3727 Water Tank Rd
7. 1/11

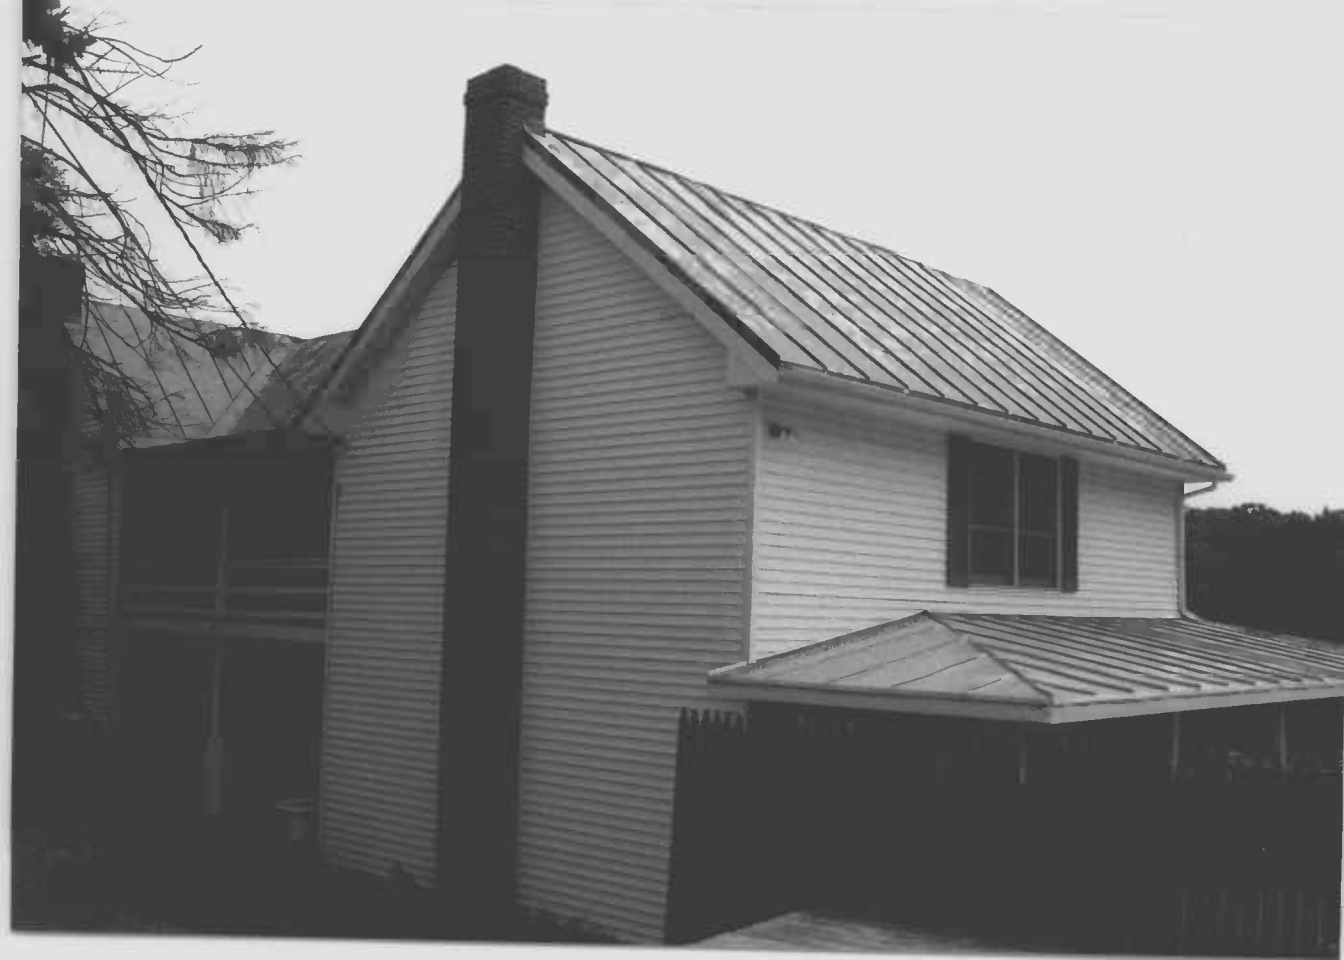
A 2-1/2 story, two bay by one bay, vinyl-sided addition was built by the current owner onto the southern elevation of the kitchen. A gallery was created on the west elevation with a porch on the second story. The metal gable roof is parallel to the main block and there is a wraparound wood porch that extends from the principal [south] facade across the east elevation. Fenestration is regular with one-over-one sash.

1. CARR 1512
2. Carroll County
3. Madeleine Scheerer
4. JUNE 1996
5. Maryland SHPO
6. Bentz FARM - house west elevation
3727 Water TANK Rd
7. 2/11

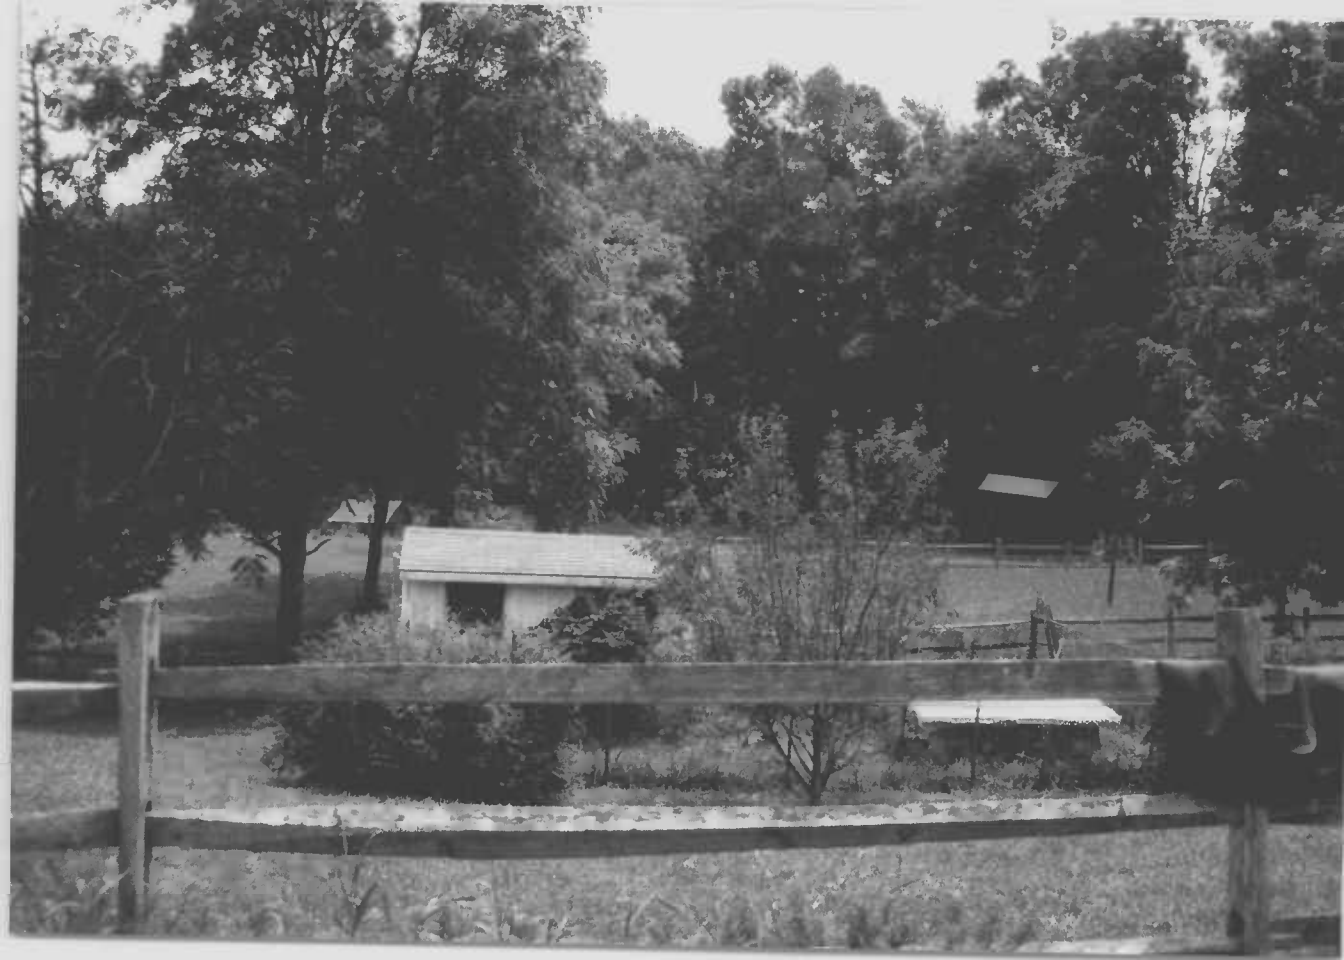
1. APRR 15/2
2. Carroll County
3. Madeleine Scheerer
4. JUNE, 1996
5. Maryland SHPO
6. Bentz Farm - shed south of house
3727 Water TANK Rd
- 7 3/11

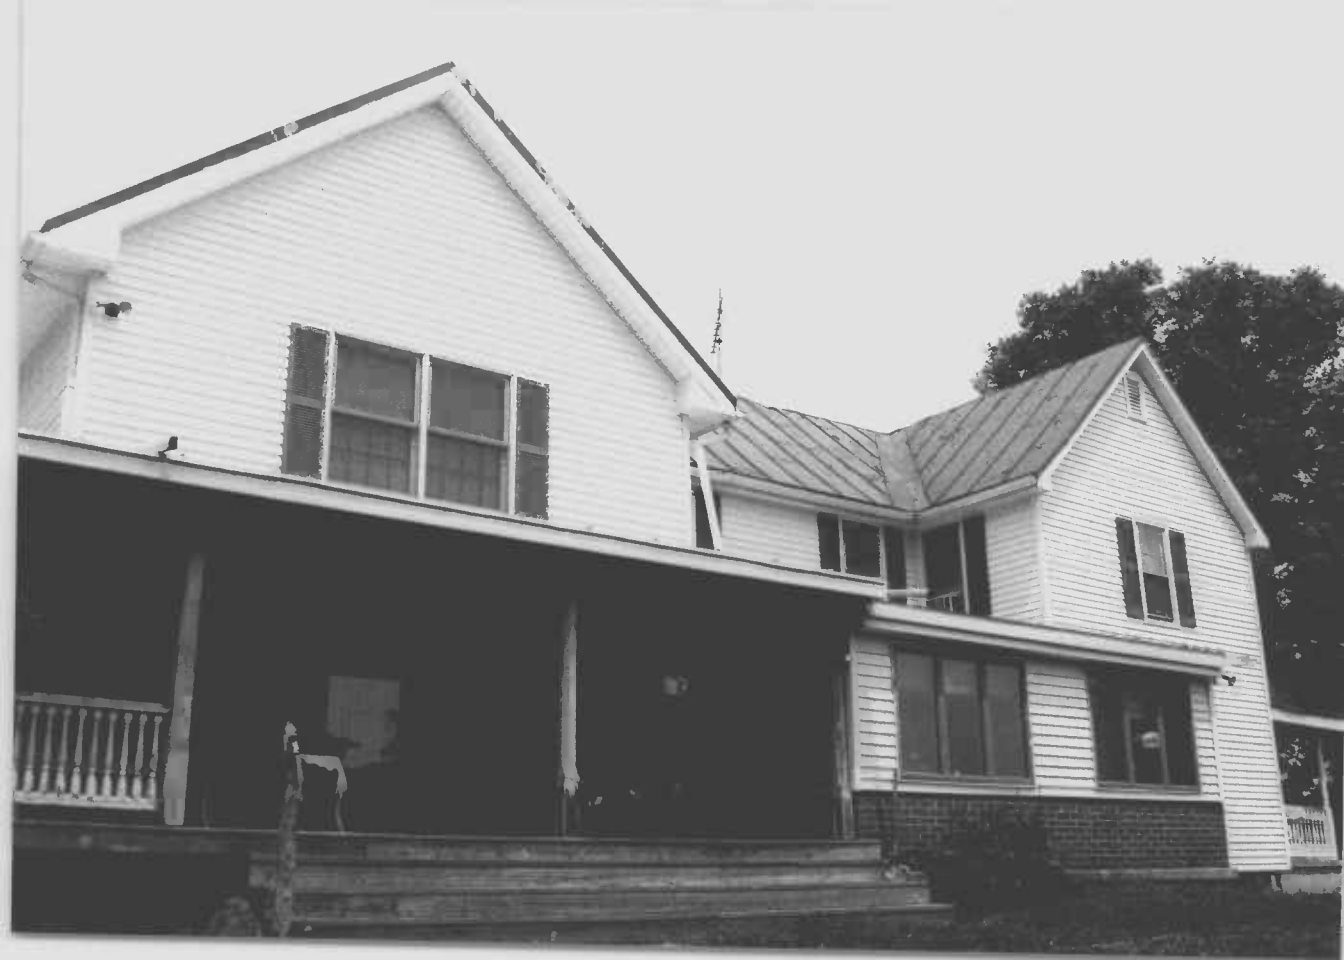
F-4/11

A two story, two bay by one bay addition is affixed to the main block's south elevation. This addition was the kitchen area for the previous owner and the starting point of a fire that partially destroyed the addition. The current owners restored the structure and also use the area as a kitchen.

1. CARR 1512
2. Carroll County
3. Madeleine Scheerer
4. June, 1996
5. Maryland SHAD
6. Bentz Farm - house south elevation
3727 WATER TANK RD

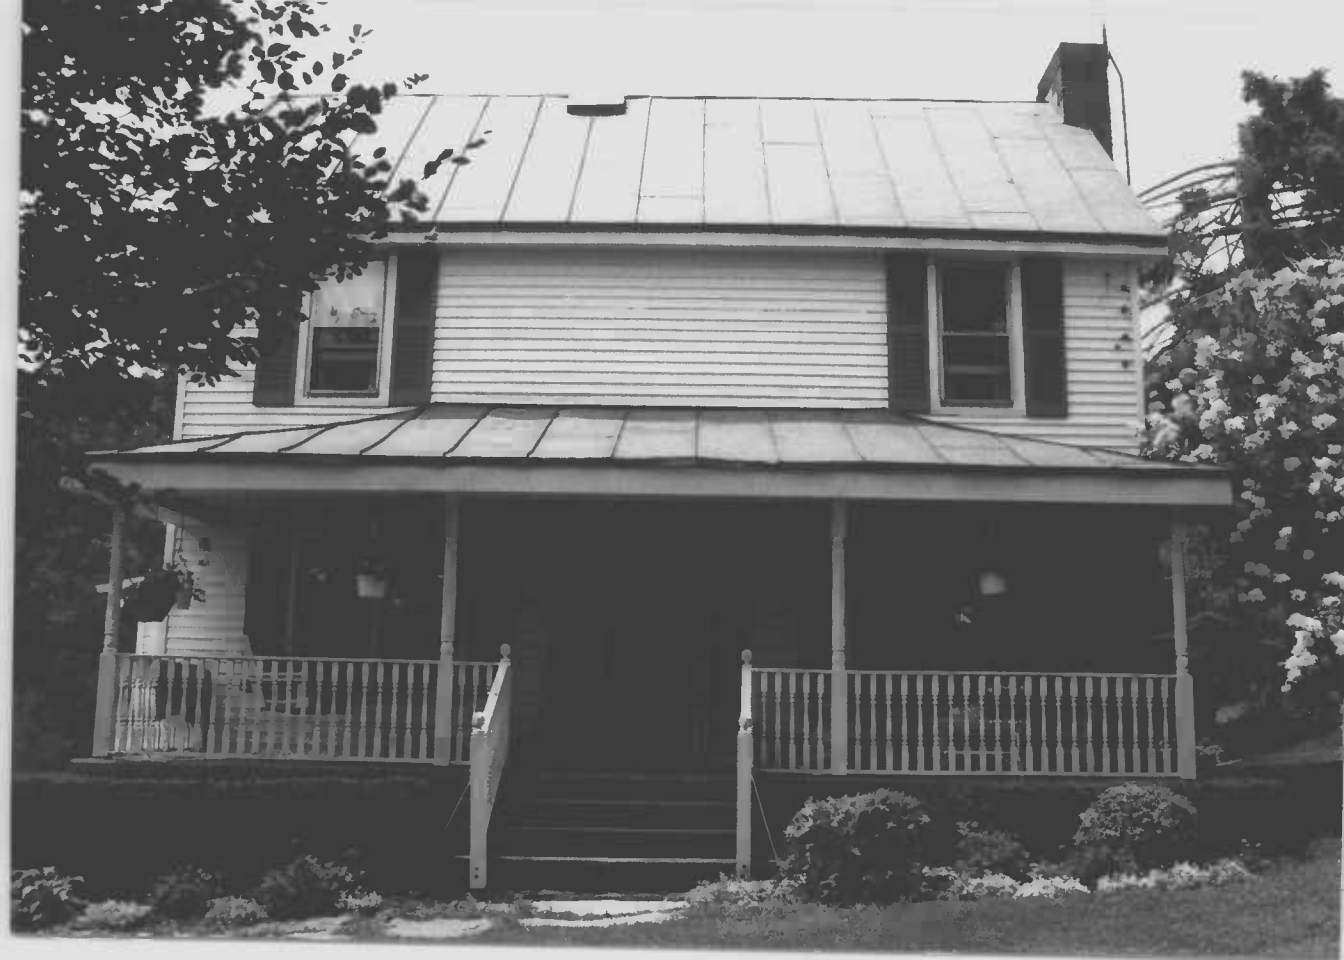
1. CAR 1512
2. Carroll County
3. Madeleine Scheerer
4. June, 1996
5. Maryland SHPO
6. Bentz Farm - house east facade
3727 Water Tank Rd
7. 5/11

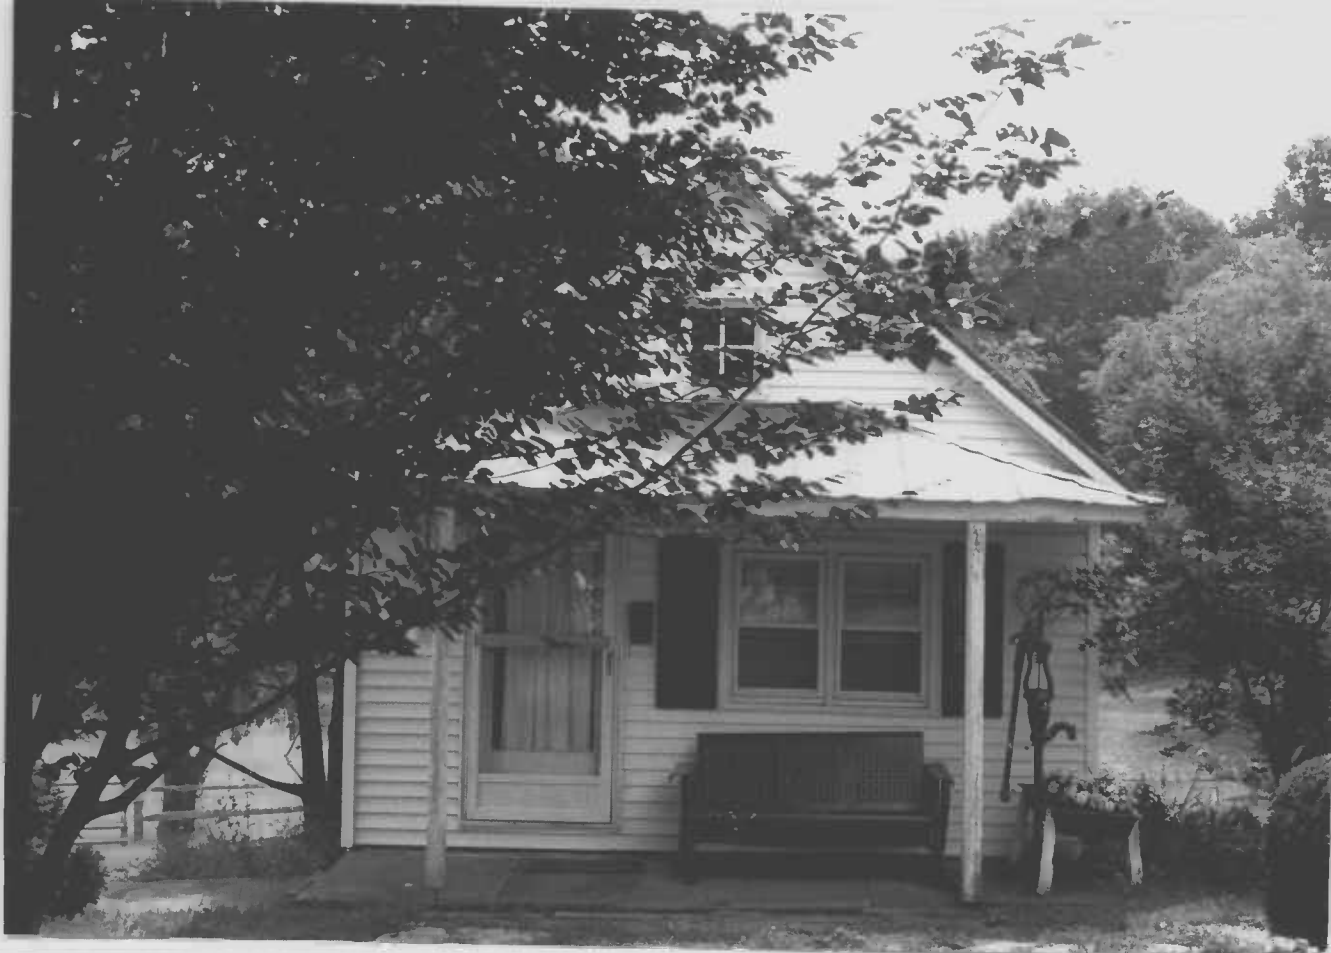
The 1-1/2 story summer house is one room with a loft area. Two bays by two bays, the clapboard structure is currently used as a tenant house and the interior has been renovated and modernized.

1. CAR 1512
2. Carroll County
3. Madeleine Scheekuk
4. June, 1996
5. Maryland SHAD
6. Bentz Farm - summer house - north facade
3727 WATER TOWER RD
7. 6/11

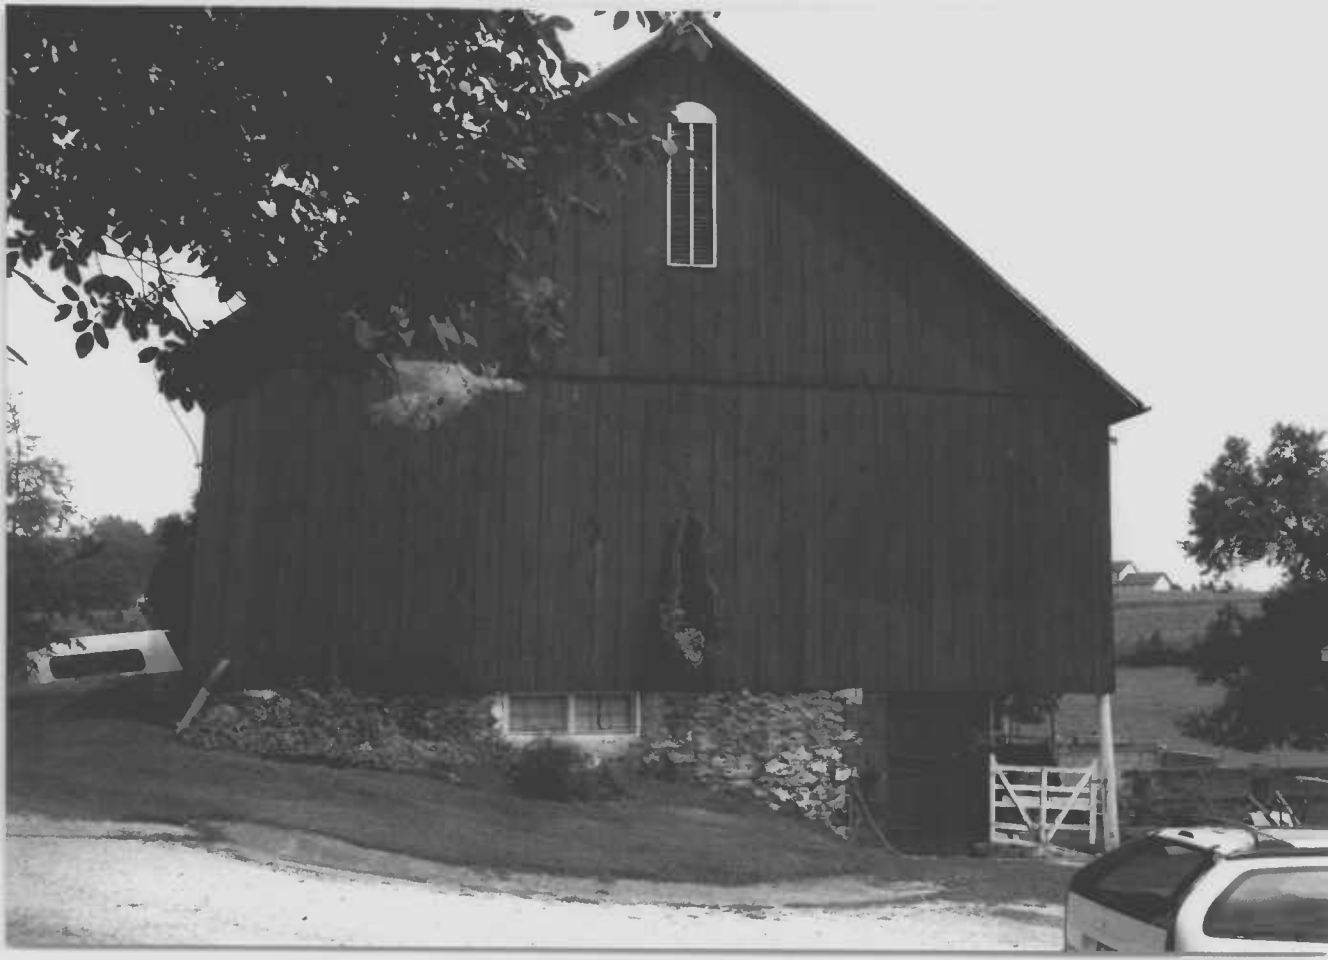
The 2-1/2 story, frame bank barn is four bays by three bays with metal gable roof topped with ventilator cupola, perpendicular to the main house. There are two, 6 lite windows with arched lintels on the ramp [west] elevation and an unsupported forebay with brick end walls oriented towards the east. The stall area in the lower level has original rough-hewn timbers for floor joists.

1. QALR 1512
2. Carroll County
3. Madeleine Scheerer
4. JUNE, 1996
5. Maryland SHPO
6. Bentz Farm - Barn lot elevation
3727 WATER TANK RL
7. 7/11

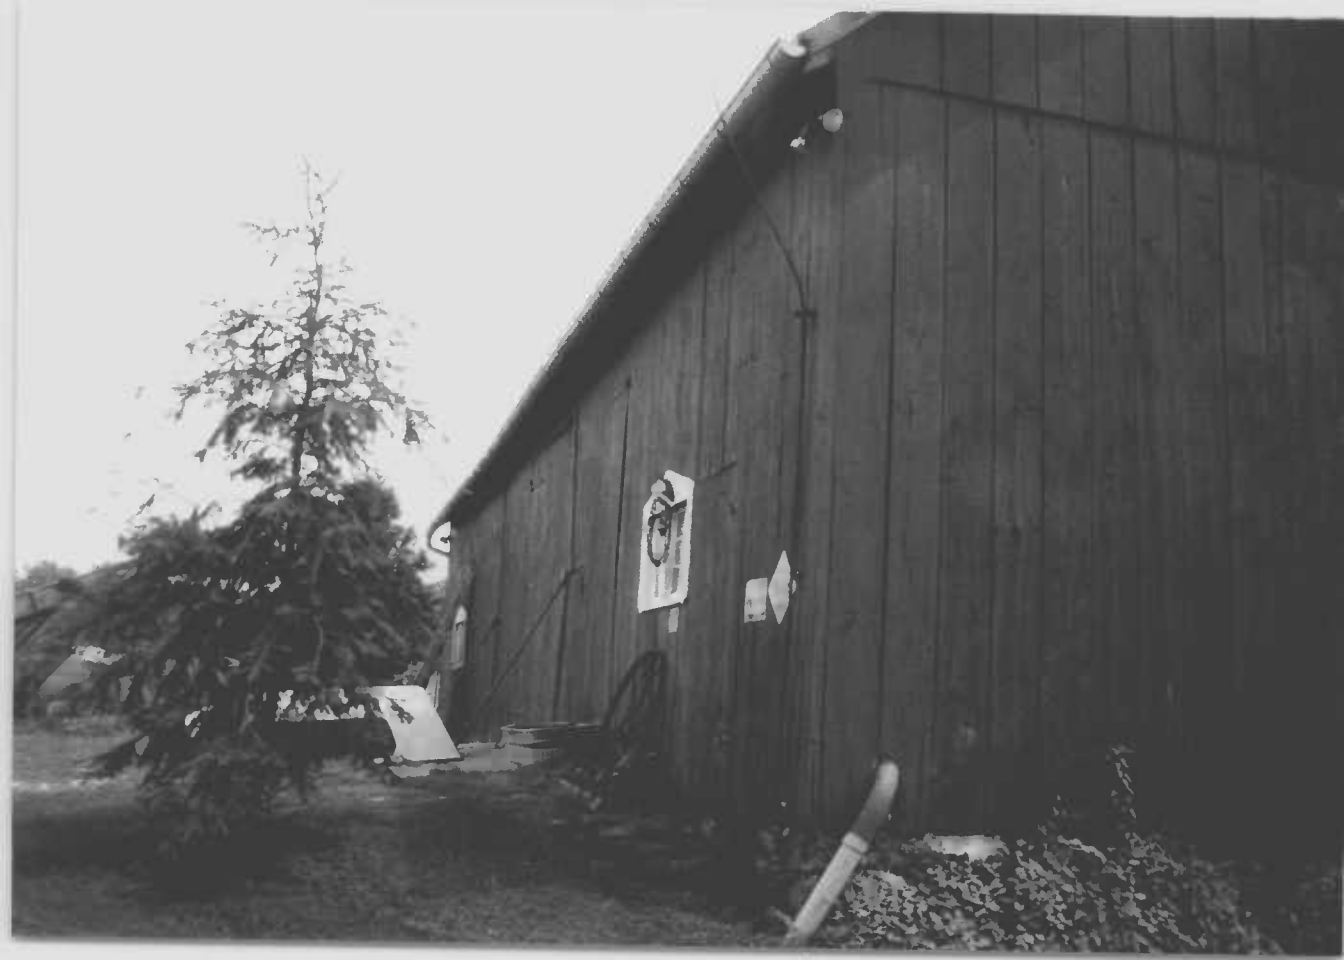
1. OPRK 1512
2. Carroll County
3. Madeleine Scheerer
4. June, 1996
5. Maryland SHPD
6. Bentz Farm - Barn north elevation
3727 Water Tank Rd
7. 8/11

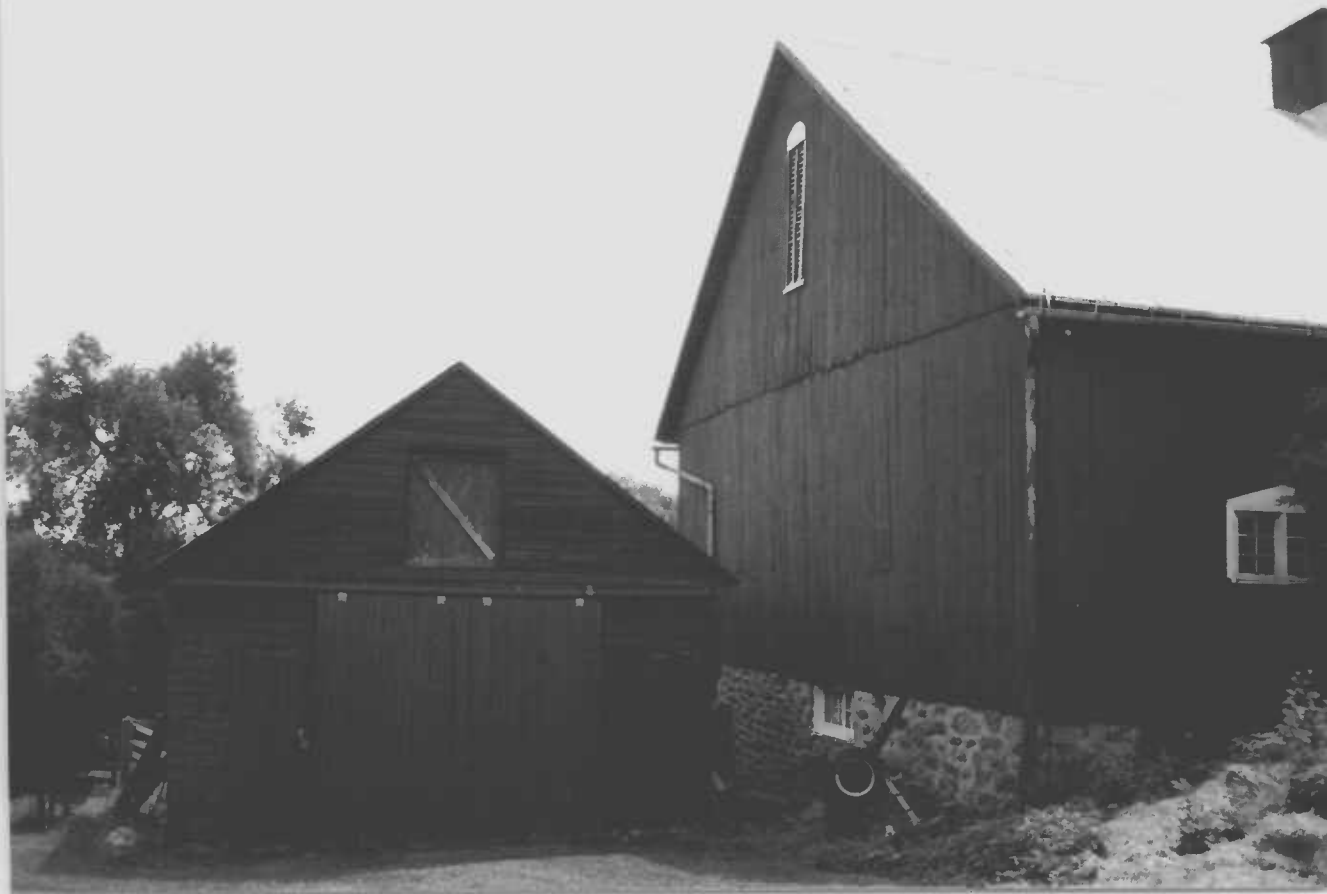
1. CAR 1512
2. Carroll County
3. Madeline Scheerer
4. June 1996
5. Maryland SHPO
6. Bentz Farm - Barn - east elevation
3727 Water Truck Rd. Cregar's hse - north elevation
7. 9/11

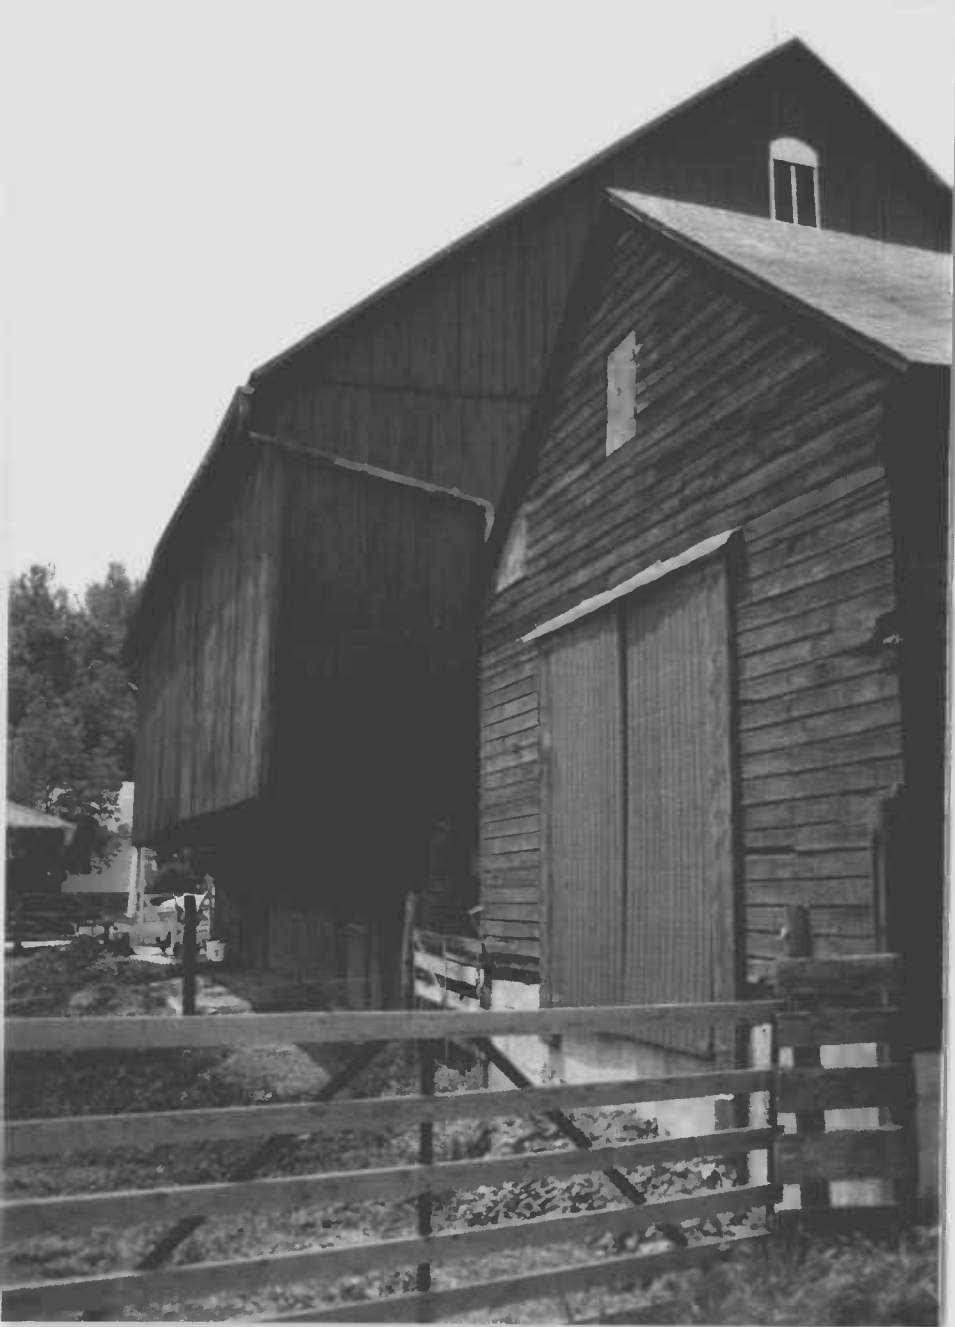
7 14/11

To the north of the barn is a 1-1/2 story, frame carriage house/corn crib combination with asphalt shingle roof parallel to the main house. A modern, cinder block garage is situated between the barn and summer house and a fieldstone and frame spring house is located east of the main house in a pasture with several frame sheds for the horses.

1. QNR 1512
2. Carroll County
3. Madeleine Scheerer
4. June, 1996
5. Maryland SARD
6. Bentz Farm - Barn leannage hse - south elevation
3727 Water Tank Rd

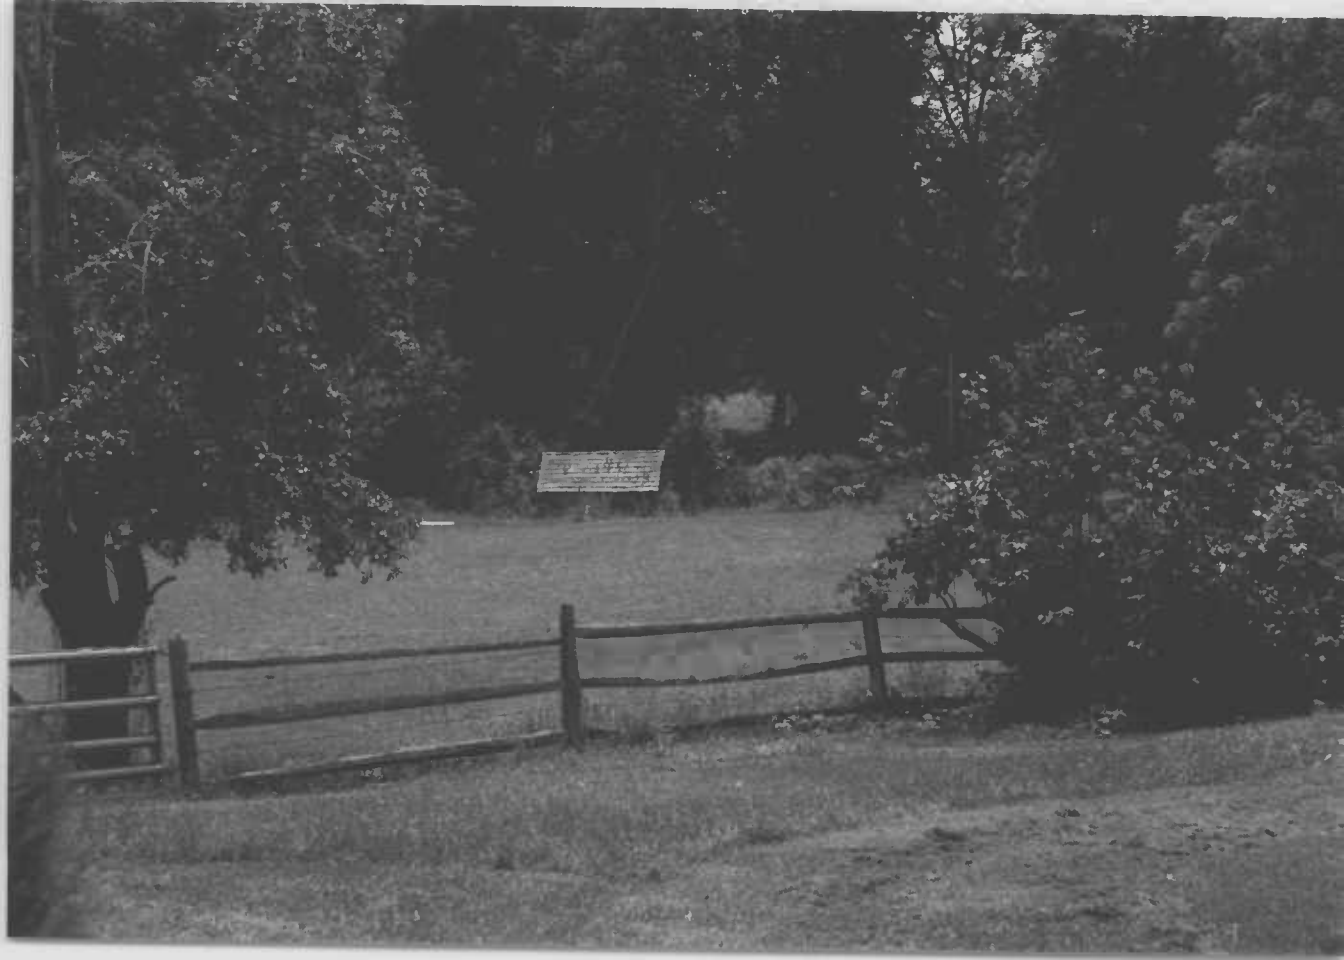
1. ~~Ch~~ 1512
2. Carroll County
3. Madeline Scheerer
4. June, 1996
5. Maryland SHPO
6. Bentz Farm - spring, hse south of house
3727 Water Tower Rd
7. 11/11
